HYDROGEN-OXYGEN ELECTROLYTIC REGENERATIVE FUEL CELLS

Contract NAS 3-2781

EOS Report 4110-ML-20

10 September 1965

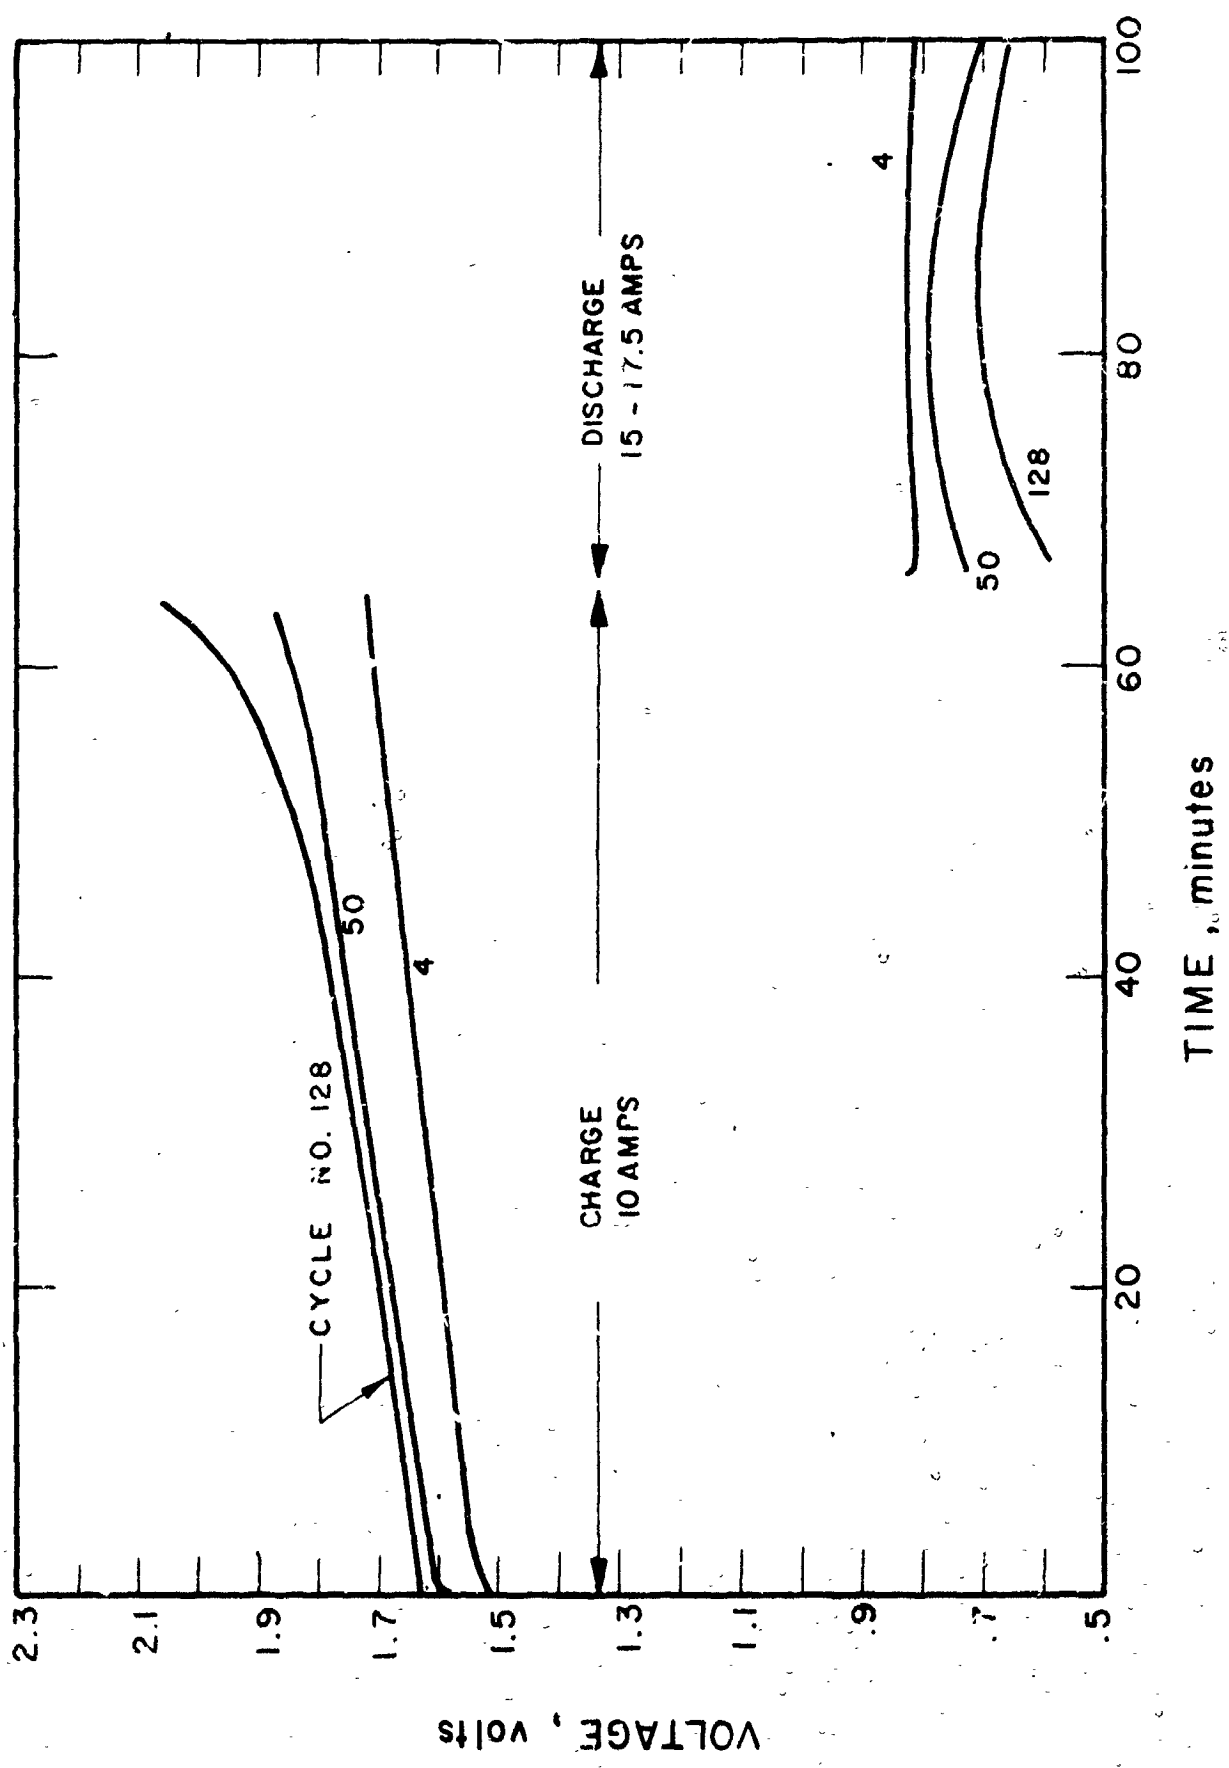
FIG. 1 CYCLING PERFORMANCE OF CELL NO. 92

Six single cell tests were conducted during this period to evaluate the performance of various electrode structures. Test results and the construction variables of these cells is summarized in Table 1. Cells number 92 and 93 were assembled utilizing oxygen electrodes purchased from American Cyanamid Corporation. These were the standard AB-4 type containing 9 milligrams of platinum per square centimeter, with the exception that the nickel substrate screen had been gold plated to minimize oxidation and corrosion. Cell number 92 was cycled 130 times on the standard 65 minute charge, 35 minute discharge test cycle. Figure 1 shows voltage performance of the cell at various cycles. As can be seen there was a gradual increase of the charging voltage, and a decrease in the discharge voltage as the cycling continued. The final electrolyte concentration within the asbestos mat was found to be between 26.2 and 26.9 percent. Examination of the cell components after the cell was disassembled revealed no obvious changes in the electrodes. The gold plating on the nickel subscreen, wherever visible, looked impervious and firmly attached to the screen.

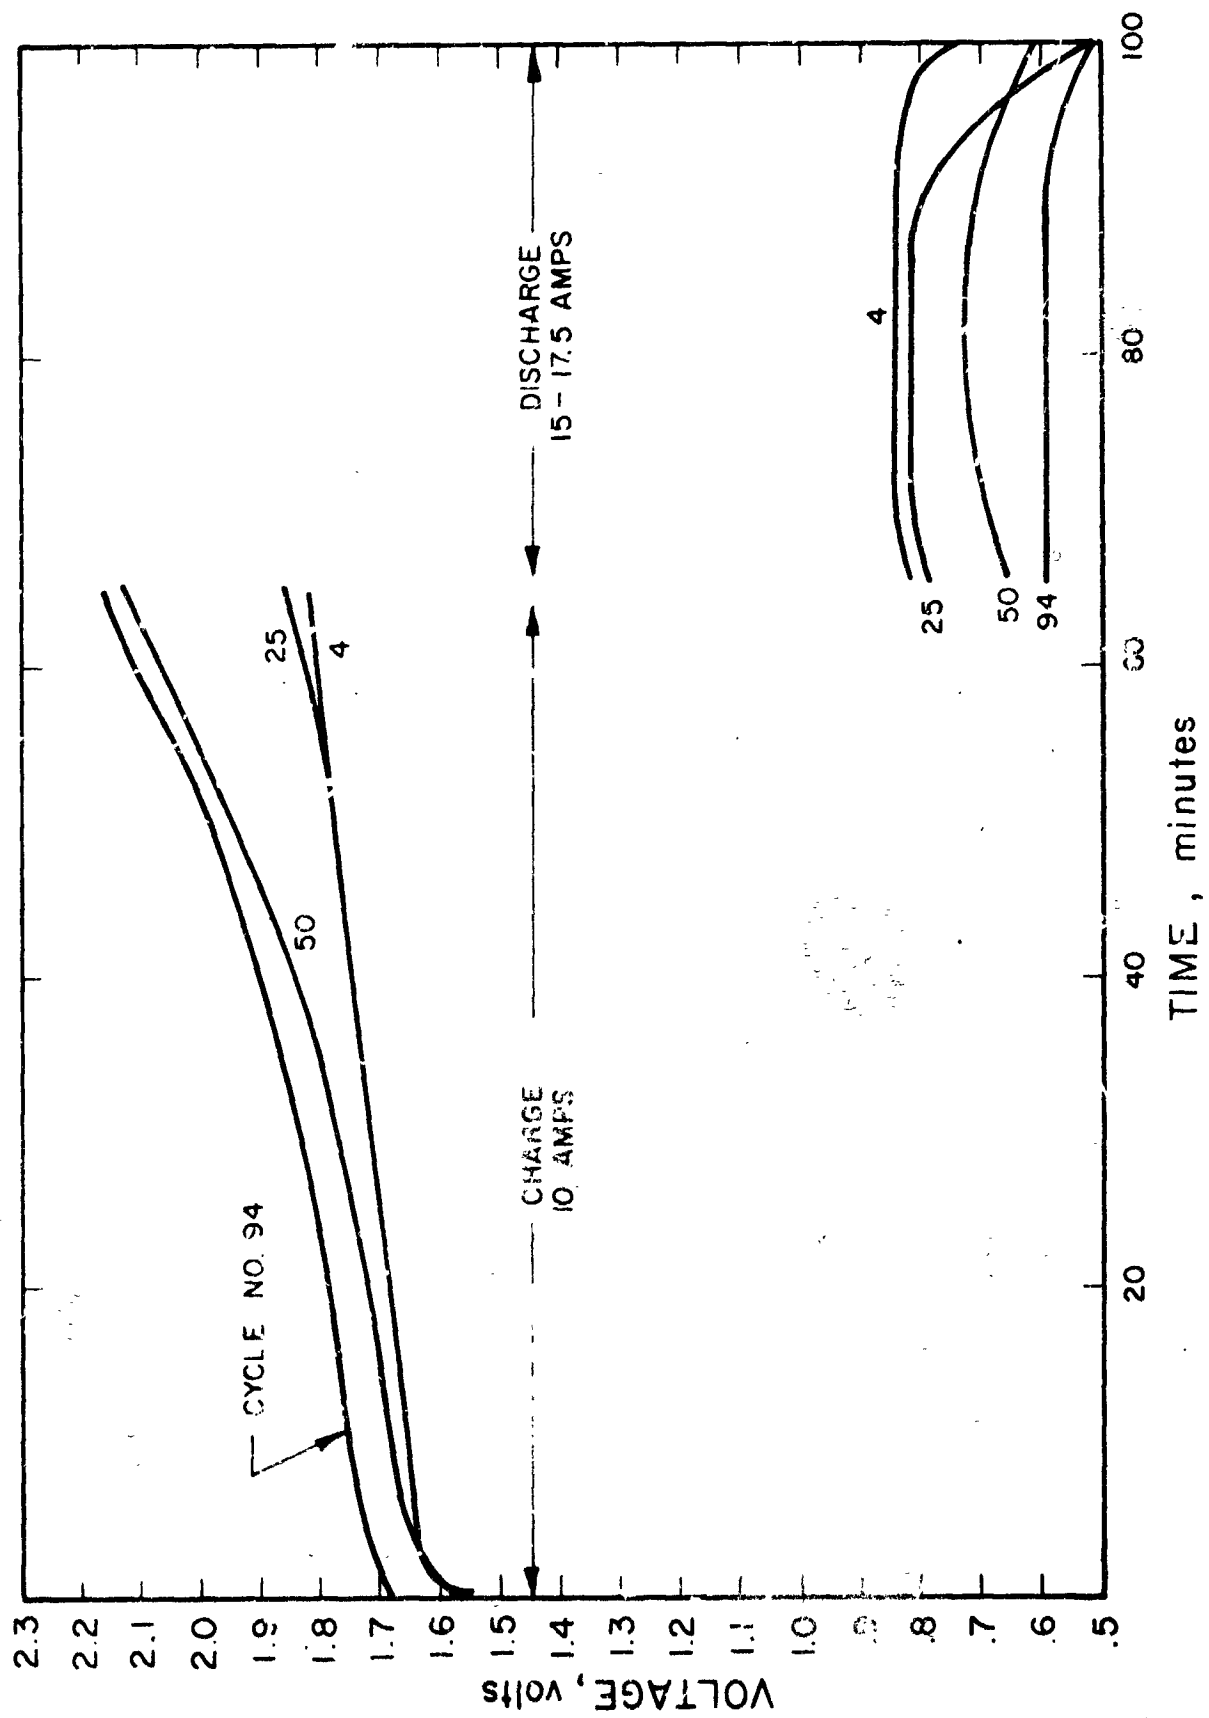
FIG. 2 CYCLING PERFORMANCE OF CELL NO. 97

Cell numbers 96 and 97 were repeats of cells 92 and 93, utilizing the same electrodes with fresh asbestos mats. Before the test each of the electrodes was washed with hot distilled water and dried. Performance obtained with cell 96 was similar to that obtained with cell number 93, i.e., the charge voltage would rise rapidly to levels as high as 2.2 volts. Discharge performance was low, ranging between 0.5 and 0.7 volts. The cell was cycled 37 times. Cell number 97 showed good initial performance, but gradually degraded with cycling. Voltage performance at various cycles is shown in Figure 2. The final KOH concentration in the mat was found to be 25.7 percent.

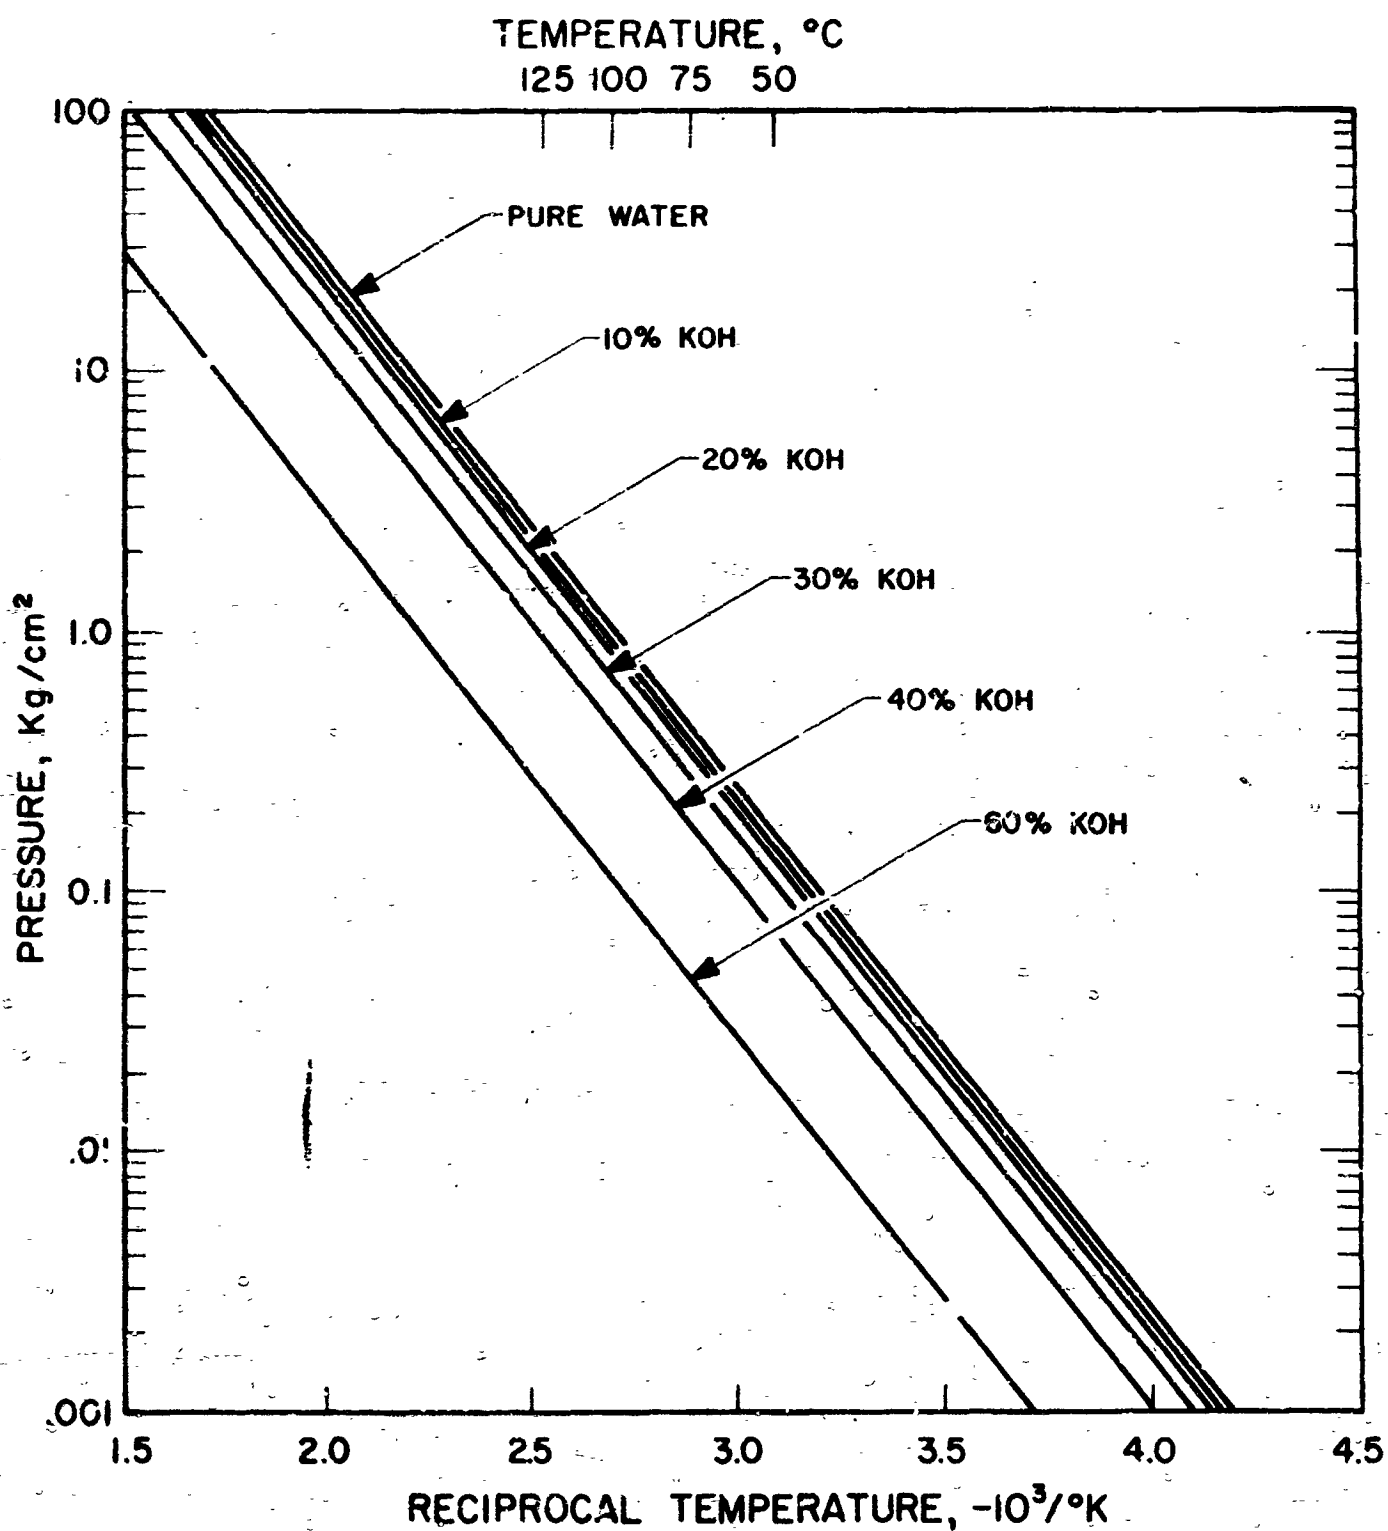
FIG. 3 SATURATION PRESSURE OF KOH SOLUTIONS VS TEMPERATURE AND CONCENTRATION

concentration. It shows that approximately 30°C temperature differences can be tolerated without exceeding the saturation pressure of the 40 percent KOH solution and water, and therefore avoiding condensation. However, since all the heat is generated by the cell stack, and the stainless steel tank is a poor conductor, the rate of heat transfer was such that the end of the hydrogen tank did not heat up sufficiently during discharge.

During cycling, substantial temperature gradients ($\approx 40^{\circ}\text{C}$) were encountered between the cell stack and the end of the hydrogen tank where the feed through was located. Typical temperatures during discharge were 110°C at the H_2 end of the cell stack and approximately 70° at the tank end. This temperature gradient apparently caused condensation of moisture in the cool end of the tank. The condensed water apparently caused the copper bus to corrode causing a metallic short from the bus to the grounded feed through connector. Figure 3 shows data for saturation pressure of KOH solutions vs. temperature and

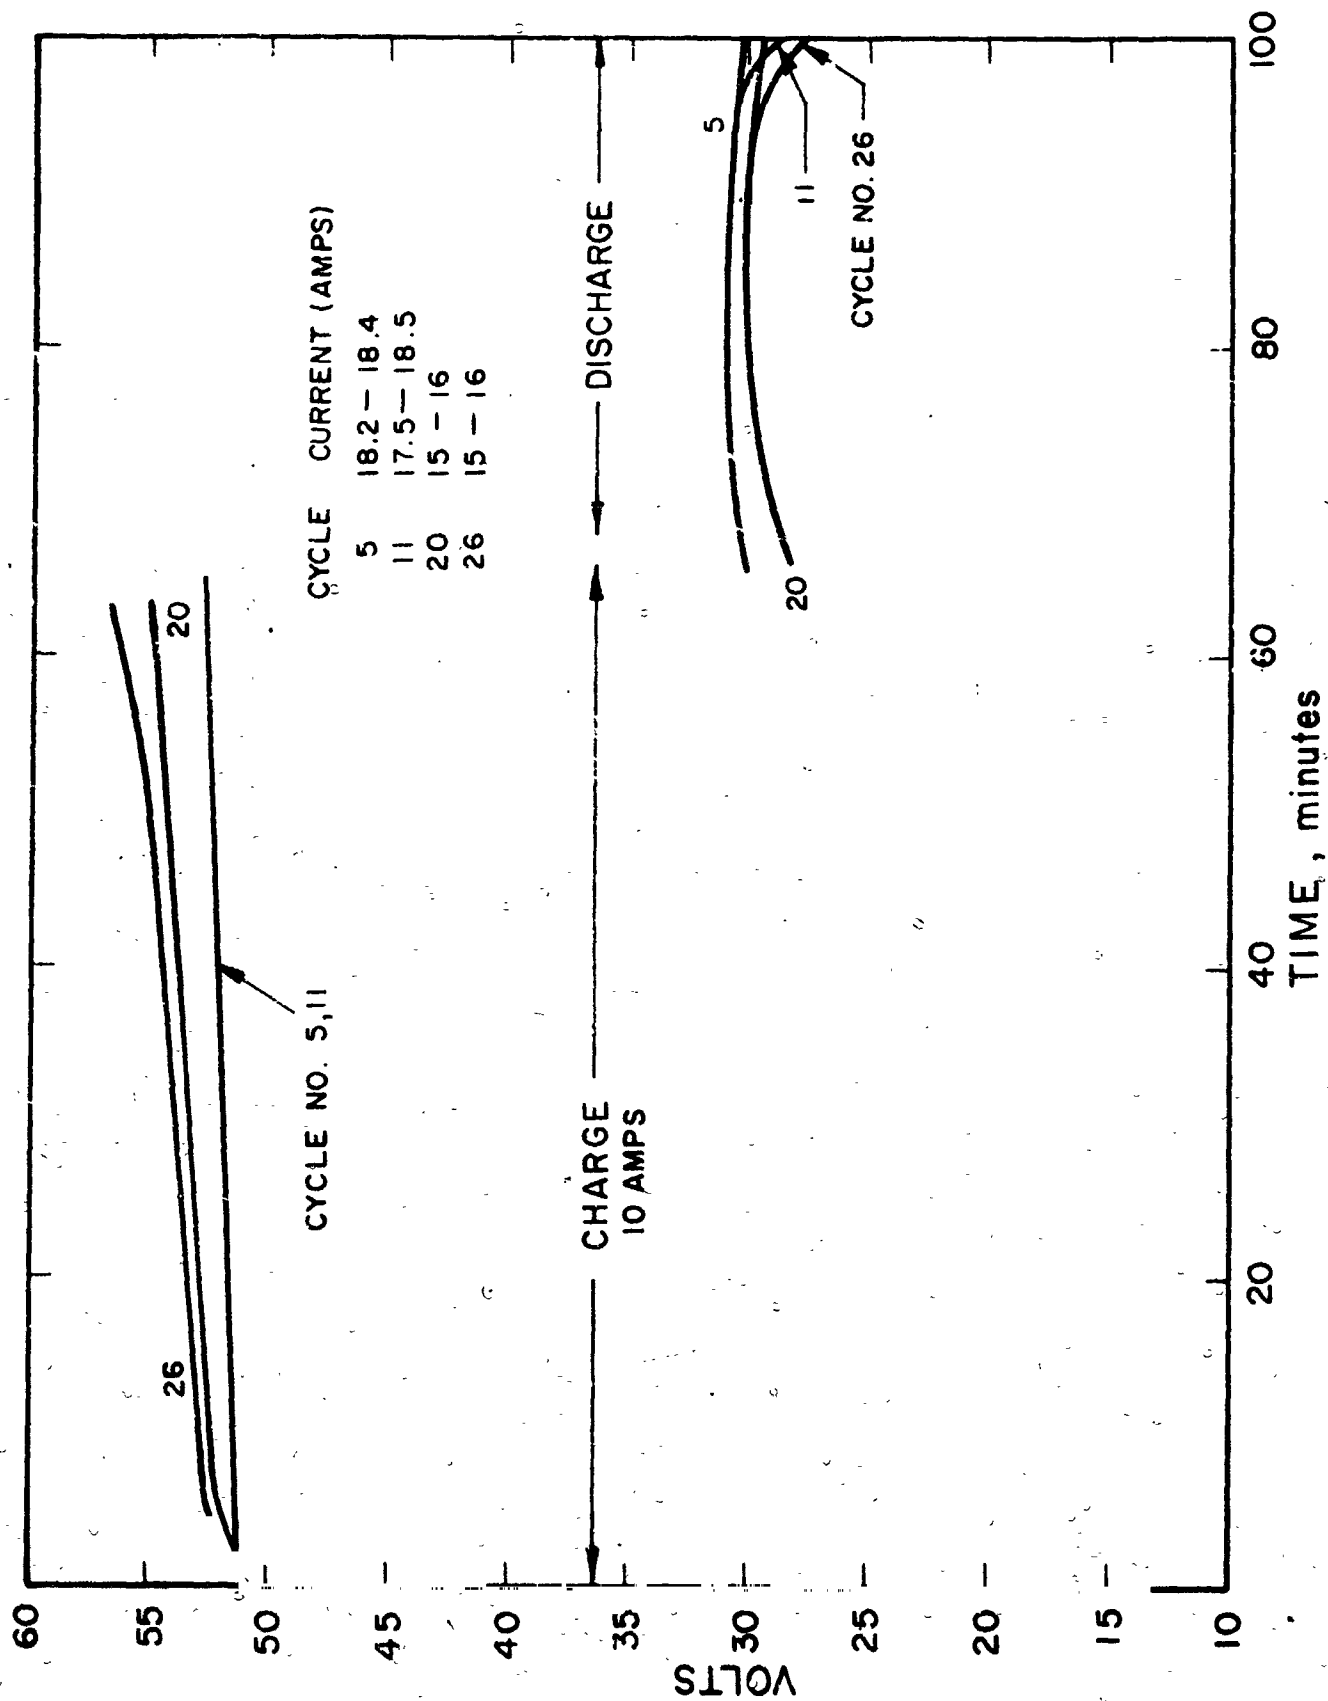
Figure 4 shows typical voltage performance of the unit during its initial cycles. Since the performance of the cell stack was quite good when the short developed, the tanks were disassembled and a new insulated feed through was installed. Asbestos insulation was wrapped around the hydrogen end of the tank in an attempt to keep the end hot enough to prevent additional condensation. The unit was subsequently cycled through the 26th discharge. During the second cycling period, a degradation in discharge voltage was observed similar to that recorded in previous single and 6 cell tests. The discharge voltage during the initial and end portions of discharge was 10-20 percent lower than at the mid point. This performance data is also shown in Figure 4. Large temperature gradients were again observed between the cell stack and the hydrogen tank end, and it was assumed that additional condensation within the unit was occurring due to this temperature gradient. Considering the gradual degradation of performance and the substantial temperature gradient encountered, it was decided to discontinue the test and make modifications on the unit to eliminate the temperature problem.

FIG. 4 CYCLING PERFORMANCE OF 500 WATT REGENERATIVE HYDROGEN-OXYGEN FUEL CELL
S/N 1002-34

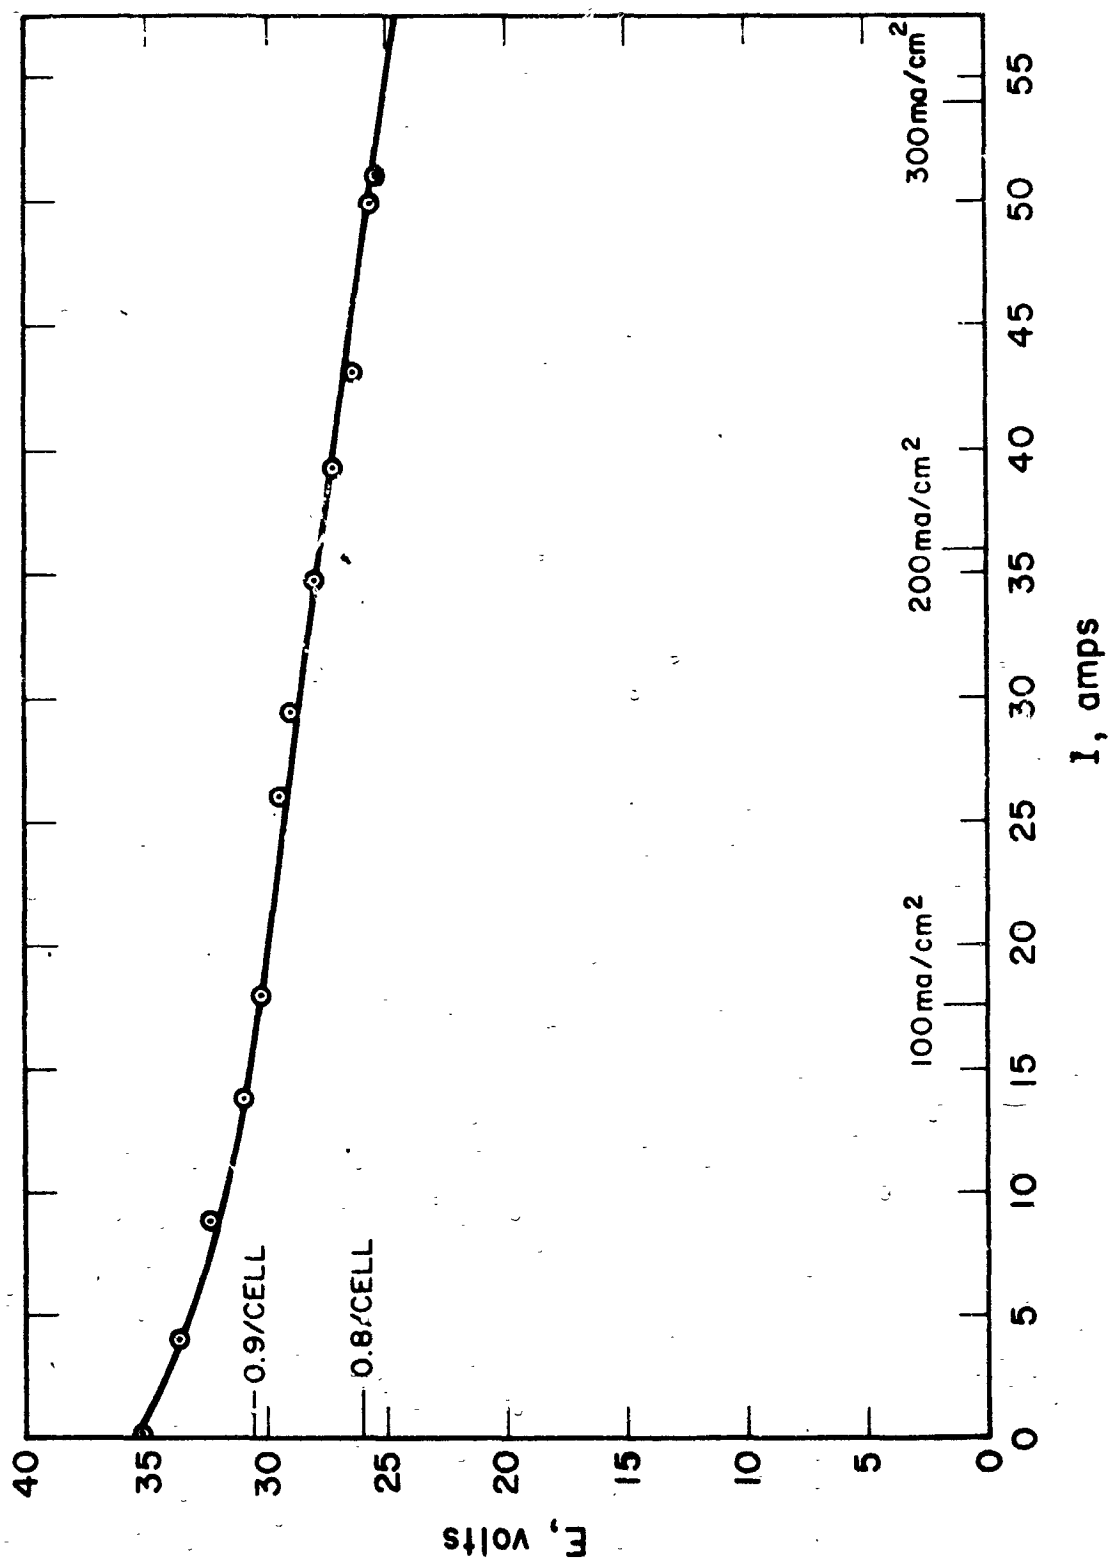
To determine overload capabilities of the unit during the 12th discharge, voltage vs current data was obtained, and is presented in Figure 5. This showed considerable overload capabilities with minimal polarizations. This data was also utilized in plotting power vs

FIG. 5 VOLTAGE VS CURRENT DATA FOR 500 WATT REGENERATIVE HYDROGEN-OXYGEN FUEL CELL
S/N '002-34

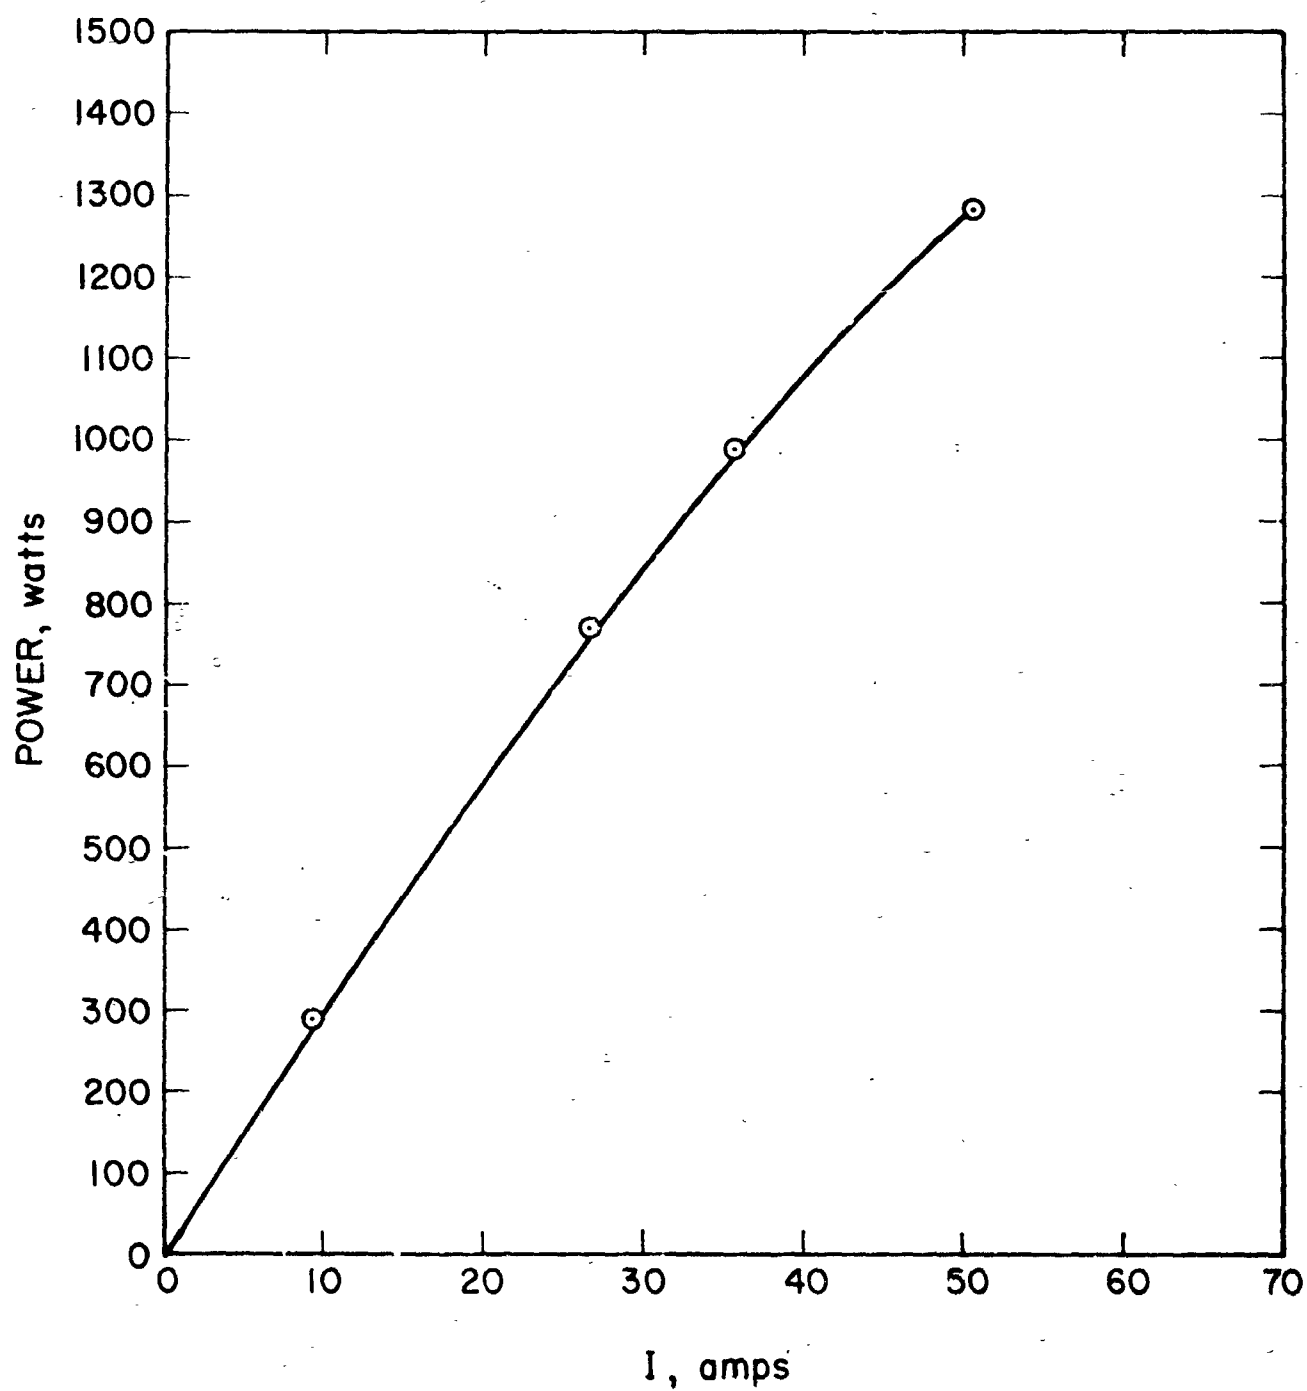
current data which is presented in Figure 6. These tests of the 500 watt unit showed that the mechanical design, including compensating bellows, tank volumes, etc. was proper, and that the unit is capable of running continuously in excess of 500 watts, and has an overload capability > 2.5 times nominal.

FIG. 6 POWER VS CURRENT FOR 500 WATT REGENERATIVE
HYDROGEN-OXYGEN FUEL CELL
S/N 1002-34
